**Report: Chilt/RF11054 Revision A**

**A fire resistance test performed on 2No.  
single leaf single acting doorsets**

**Test conducted in accordance with  
BS 476: Part 20/22: 1987**

**Prepared for: Firestop Manufacturing  
Ltd  
4 Wyvern Buildings  
Grove Industrial Estate  
Dorchester  
Dorset  
DT1 1ST**

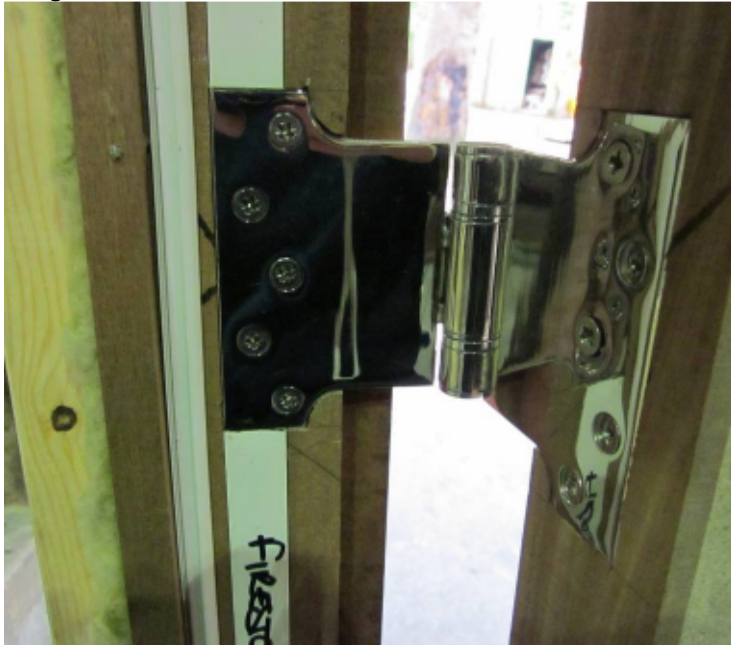
Hinge – doorset A

| | Make/type | Size (mm) | Location |
|---|---|---|---|
| Around hinges | Fully interrupted | - | Hinge blade fully interrupts seal in frame reveal |
| Under hinge blade | Firestop Manufacturing Ltd<br>intumescent sheet material<br>Product reference FS318 | 0.8 thick | Fitted under the hinge blade on frame and leaf |

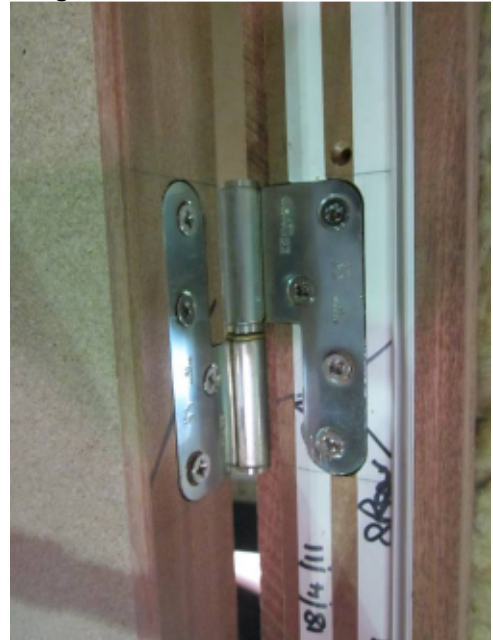
Hinge – doorset B

| | Make/type | Size (mm) | Location |
|---|---|---|---|
| Around hinges | Partially interrupted | - | Hinge blade fully interrupts 1 <sup>st</sup> seal and partially interrupts 2 <sup>nd</sup> seal leaving 11mm continuous in the frame reveal |
| Under hinge blade | Firestop Manufacturing Ltd intumescent sheet material<br>Product reference FS318 | 0.8 thick | Fitted under the hinge blade on frame and leaf |

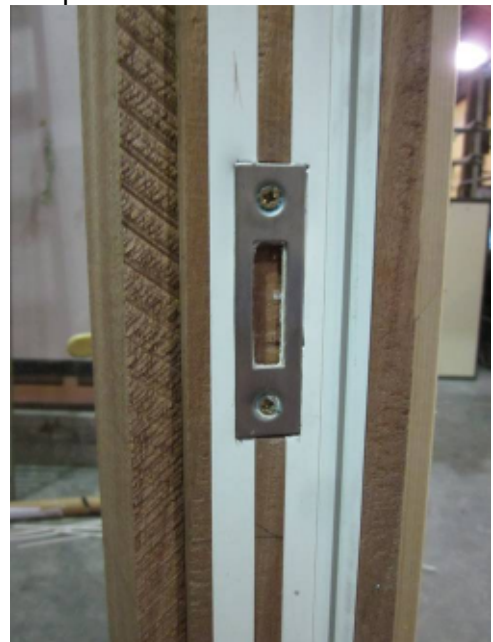
Keep – doorset B

| | Make/type | Size (mm) | Location |
|---|---|---|---|
| Around dead bolt keep | Partially interrupted | - | Latch keep partially interrupts both seals in the frame reveal with 7mm of the 1 <sup>st</sup> seal and 8mm of the 2 <sup>nd</sup> seal remaining continuous |
| Under latch keep | Interdens | 1 thick | Fitted under the latch keep |
